Heritage Park

- ❖ Irrigation System Inspection
- ❖ Review of Water Use
- ❖ Estimated Water Budget
- ❖ Potential for Savings

Site Visit: January 17, 2008

Address: 611 Village Drive, Suisun City

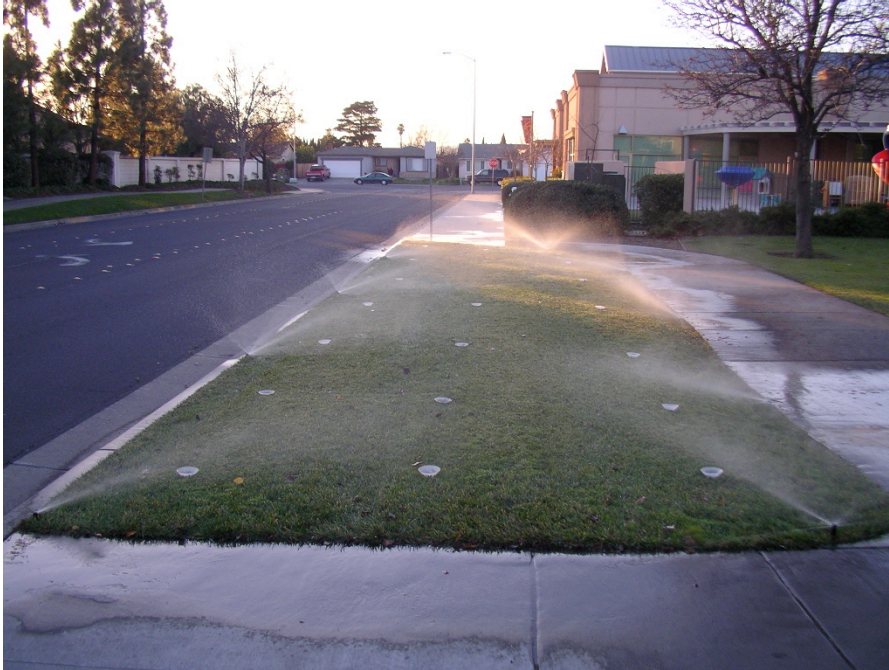
Problem: Overspray caused by high pressure (50 psi) and runoff caused by poor alignment on edges.

Solution: Reduce pressure to 30 psi and align sprinklers along edges.

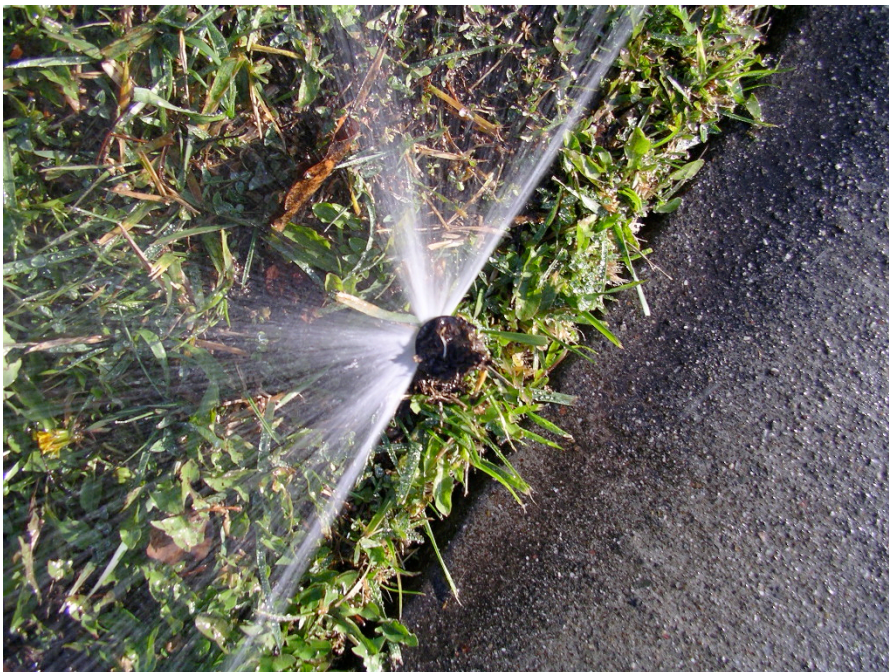
Problem: Nozzles on some of the popup spray sprinklers were blocked or damaged. This causes stress and brown spots in the turf.

Solution: Check and replace nozzles as needed.

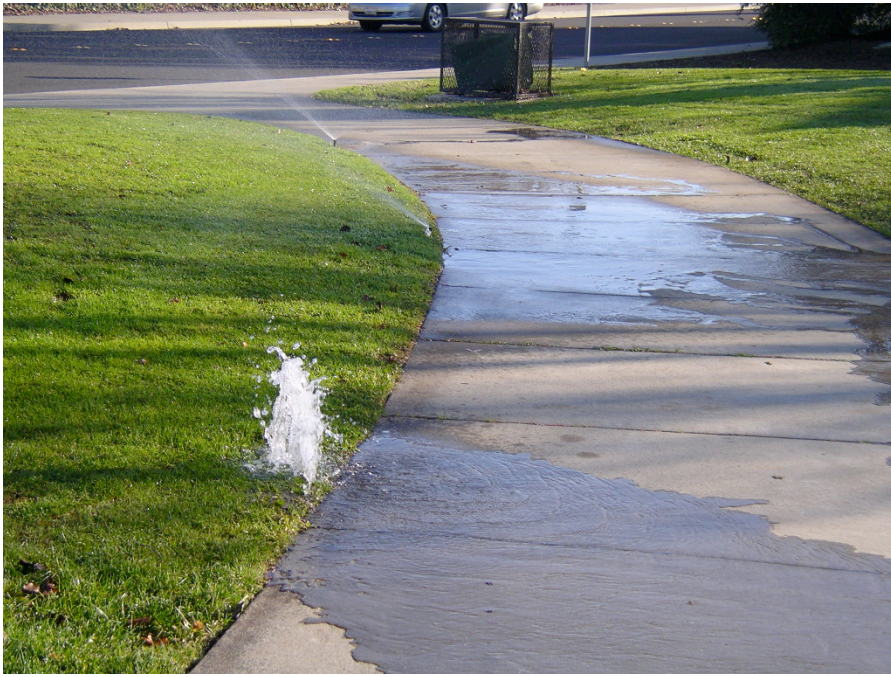
Problem: Damaged sprinklers along walk

Solution: Repair, and re-locate inboard of hardscape edge 4 inches or more.

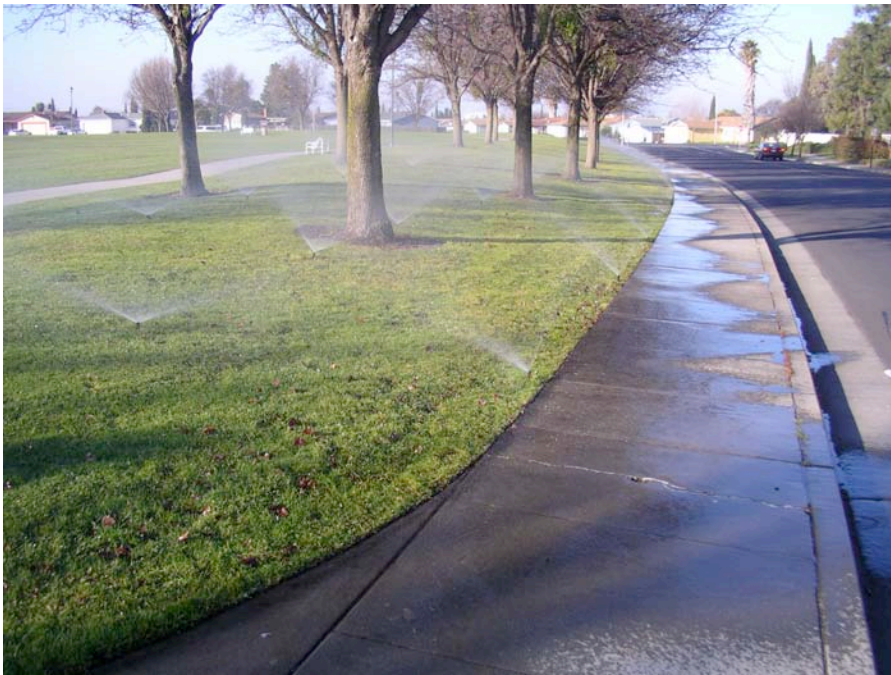
Problem: Overspray in the area of the school bus stop.

Solution: Move station up in the controller “A” firing order. Reduce pressure and align sprinklers along hardscape.

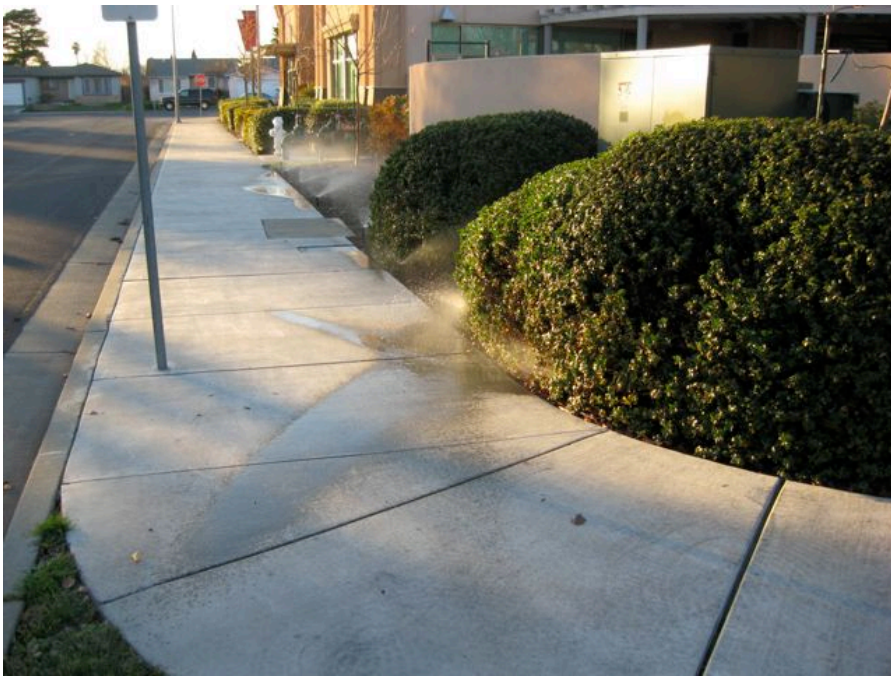
Problem: High pressure in shrub spray station.

Solution: Reduce pressure to 30 psi and align sprinklers along edges.

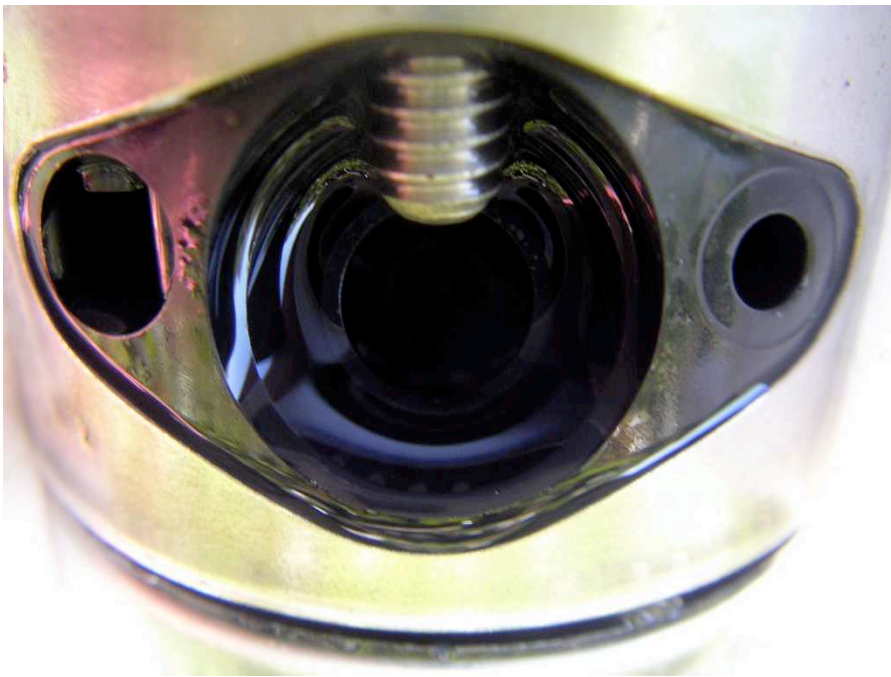
2. Nozzle selection for large turf rotor sprinklers is critical. With this site's average Head-to-Head spacing of 50 feet, the suggested nozzle for Hunter I-40 heads would be #42 or 43 versus the #45 installed. Mixed sprinkler types -- I-40 and I-60's on the same valve -- pose additional problems in nozzle selection and sprinkler radius.

Problem: Large #45 nozzles, installed with the Hunter I-40 sprinklers, create high flow conditions which reduces pressure in most of the rotor stations.

Solution: Consider re-nozzling with the #42 or 43 nozzles. Do this on an experimental basis before committing to changing a large number of stations.

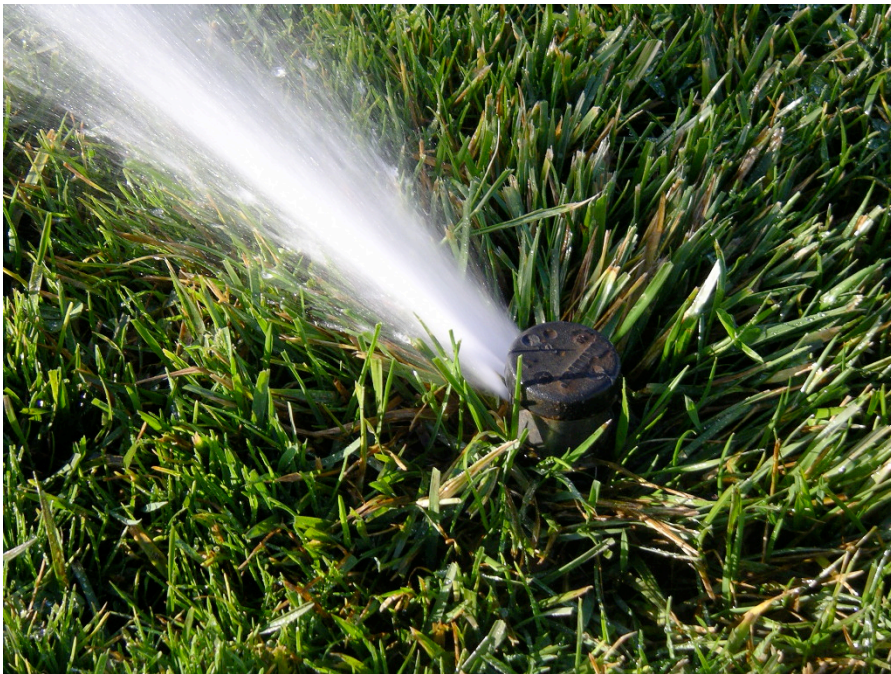
Problem: Rotor sprinkler set too low in the turf causes accumulation of water around the head. This creates soft soil which can destabilize the head. In addition the nozzle retention screw is splitting the main stream of water.

Solution: Raise the sprinkler to grade which allows spray to clear the surrounding turf. Set the retention screw to barely touch the water stream.

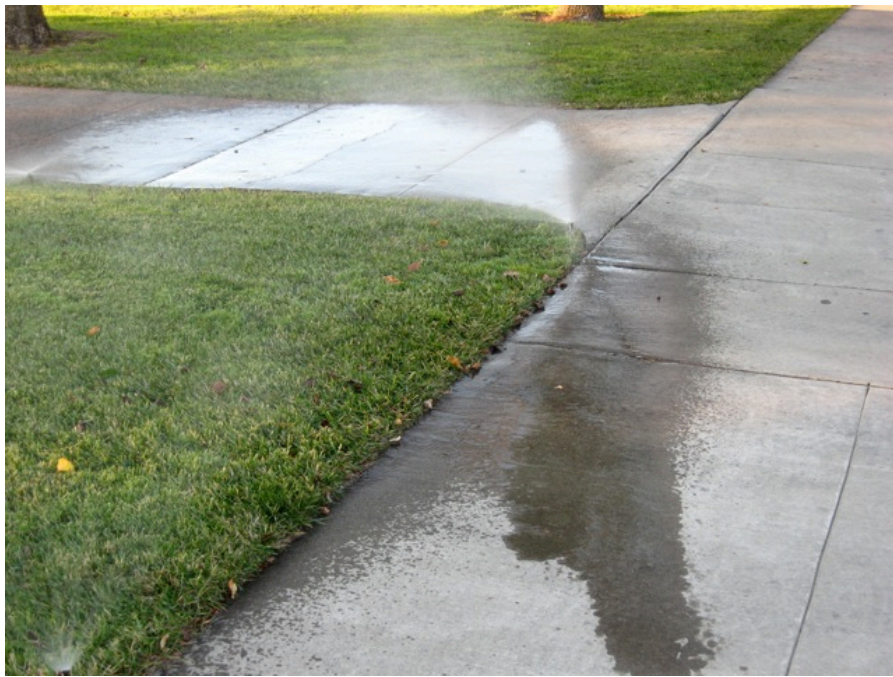
Problem: Incorrect nozzle arc for square corner leads to overspray.

Solution: Use proper fixed arc nozzle.

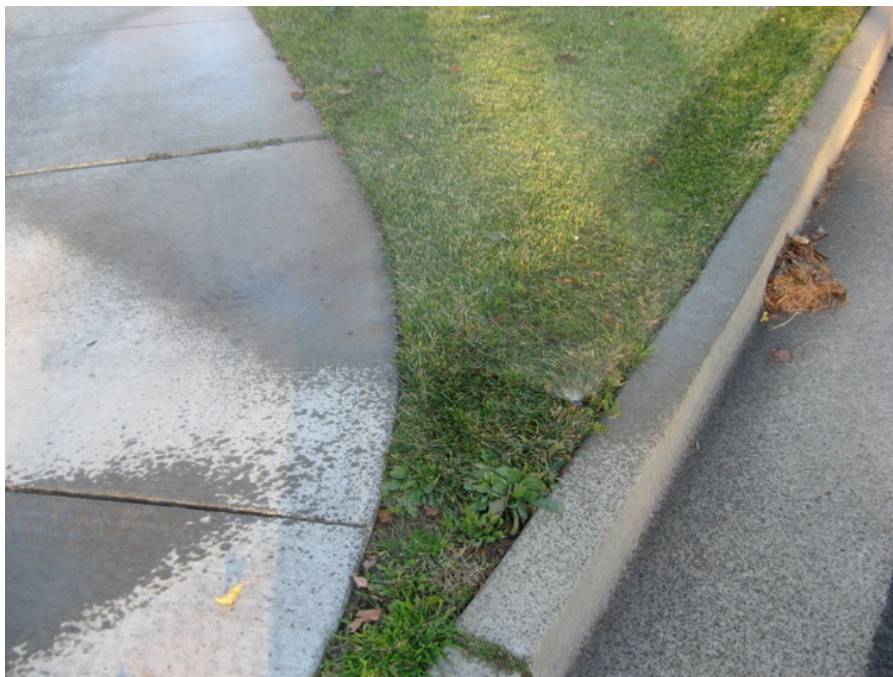
Problem: Incorrect nozzle arc for unusual arc leads to overspray.

Solution: Use adjustable arc spray nozzles as required. Convert narrow turf strips to pavers or cement.
